ACTION A.2: Ex-Ante Monitoring

Sub-action A2.3 Ex-ante Monitoring in Amvrakikos Lagoons, Logarou Lagoon

LIFE19NAT/IT/000264 LIFE-TRANSFER

Seagrass transplantation for transitional Ecosystem Recovery

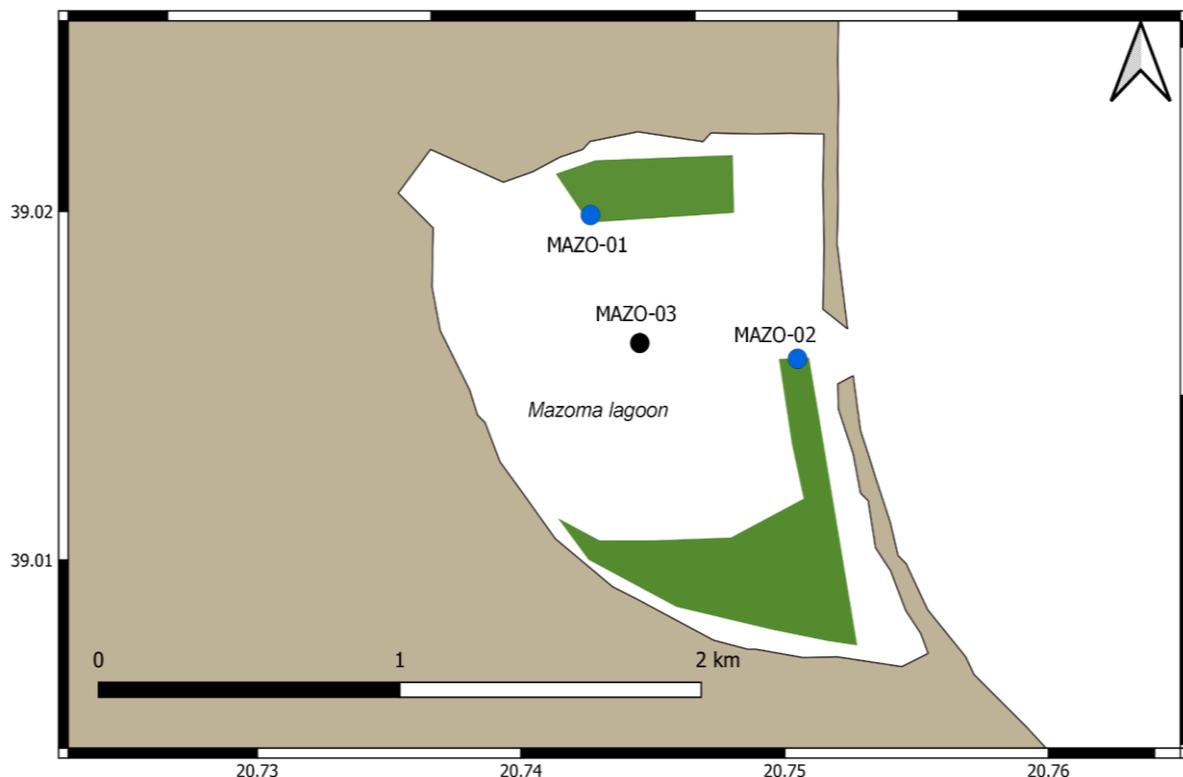
Figure 1. An indicative map of *Zostera* meadows in relation to stations in Mazoma lagoon. Green polygons depict the extent of *Zostera* meadow, while sampling stations in blue colour indicate where only physico-chemical parameters of the water column were taken.

The in-situ survey identified two areas within the lagoon (one in the northern part of the lagoon, and one close to the sea openings and along the southern coasts) where seagrass meadows extend to more than 500 ha (Figure 1A, B). In general, the lagoon appears well oxygenated (All stations >100 % dissolved oxygen; Table 2), relatively shallow (<1.3 m depth in the centre, Table 2), and the sediment substrate has a high percentage of fine sediments (>70%; Table 3). During the ex-Ante sampling campaign period (Spring 2021) relatively low levels of nutrients (phosphates, nitrates and silicates) were observed in the water column in line with previous studies of Mazoma lagoon in the same season (Vasileiadou et al. 2016). At the time of sampling the salinity throughout the lagoon was around 22 psu, and the temperature of the water column ranged from 17.2 - 18.4 °C. The ecological status of the macrobenthic community was only measured at one station (MAZ-03; Figure 1) where incidentally seagrasses were not found, however despite this, the ecological status of the MAZO-03 station (based on the M-AMBI index) is classed as “Good” with a high percentage of fine fraction sediment (>70%; Table 3). Considering the relatively large extent of seagrass meadows and its good ecological status, Mazoma lagoon appears to be a suitable donor site for the transplantation of *Zostera noltei*.
